# Achimota Brewery, Diageo – Ghana Equipment – Seitz Orion 100

**Reason for visit:** Following audits and work carried out at other Diageo sites, the brewery in Ghana contacted Puresep to carry out a full quality audit to assess the current running condition of the filter and make recommendations on optimising production.

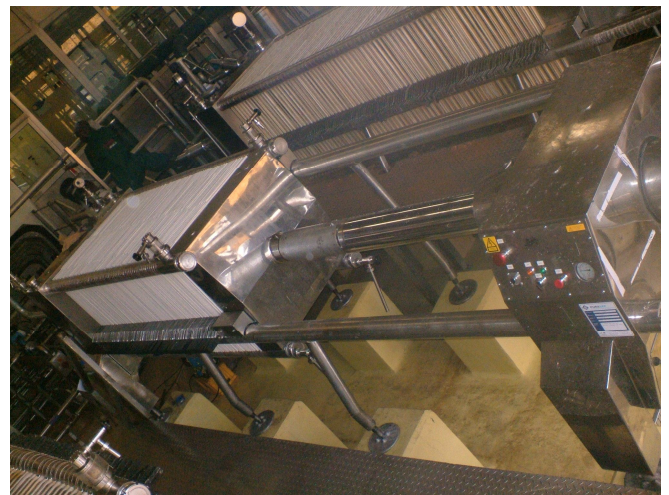
- Missing and worn shoes thus affecting the alignment of the pack – if left this would cause a decrease in productivity.
- The seals were showing sign of wear which would develop into leaks and large product loss.
- The pressure gauge assemblies have lost the indicator needles resulting in inaccurate pressure management .
- Issues with clutch assembly and locking motor – although a hydraulic strip down would be required to inspect. This resulted in the hydraulic seals being overworked – if these seals were to fail it would lead to massive product losses
- Electrical issues due to modification of control circuit – incorrect switches and no cable markers, no electrical drawings onsite or keys to unlock the old style pressure switches that were set at the wrong switching points for safe operation of the filter.

- Following our recommendations the following work was carried out
- We supplied 13 pairs of reconditioned plates and frames. This gave the brewery the capability to increase the square meterage and so the filter can run faster for longer thus increasing volumes,

- throughput and flow rate.
- New seals, shoes and handles for all the elements were supplied thus reducing powder or product leakage or break through
- Electrical, mechanical and process overhauls – leaving all equipment running at its optimum capability
- Hydraulic overhaul -all seals were changed and the electrical control panel was replaced
- The old pressure switches were replaced for digital set point pressure switches
