## **Case Study**

## **Envirogen Water Technologies Minimise Water Wastage At Large Production Site In The UK.**

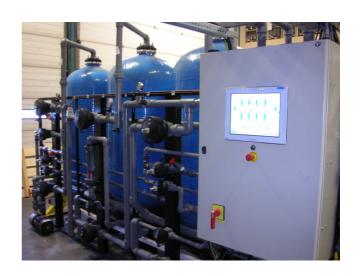
A Deioniser system

- Introduced a deioniser in the overflow line
- Increased the flow of water through the tanks via the overflow system already in place
- Added particulate filters, and an additional Deionised return tank with supporting pipe work, to ensure the water quality was maintained
